SLAC Accident Summary

The Accident

On October 11, 2004, at approximately 11:15 am, a subcontractor electrician working at the Stanford Linear Accelerator Center (SLAC) received serious burn injuries requiring hospitalization due to an electrical arc flash that occurred during the installation of a circuit breaker in an energized 480- Volt (V) electrical panel.

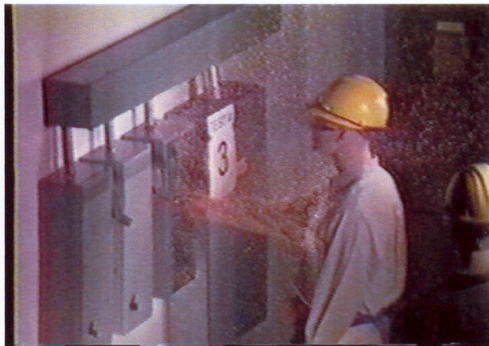
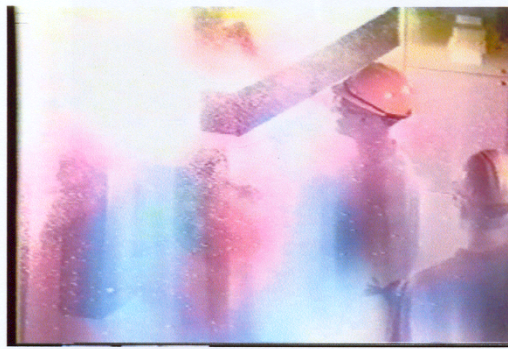
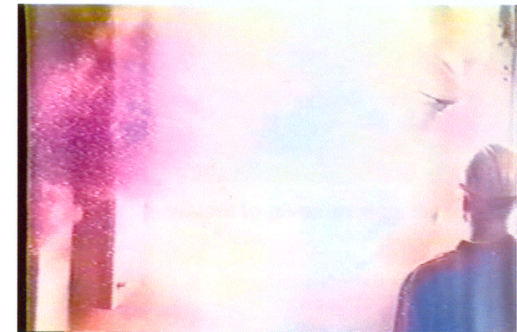
When an arc flash occurs the temperatures can reach 35,000° Fahrenheit (F). Exposure to these extreme temperatures burns the skin and causes ignition of clothing, which adds to the burn injury.

—Arc flashes can and do kill at distances of 10 feet.

Note: Test dummy used for demonstration
